**WOOD PROTECTION COMPANY
SITE INSPECTION**

**Texas Water Commission
State Superfund Unit**

Re: Site Inspection of Wood Protection Company
JN 117203
TWC 14-70020

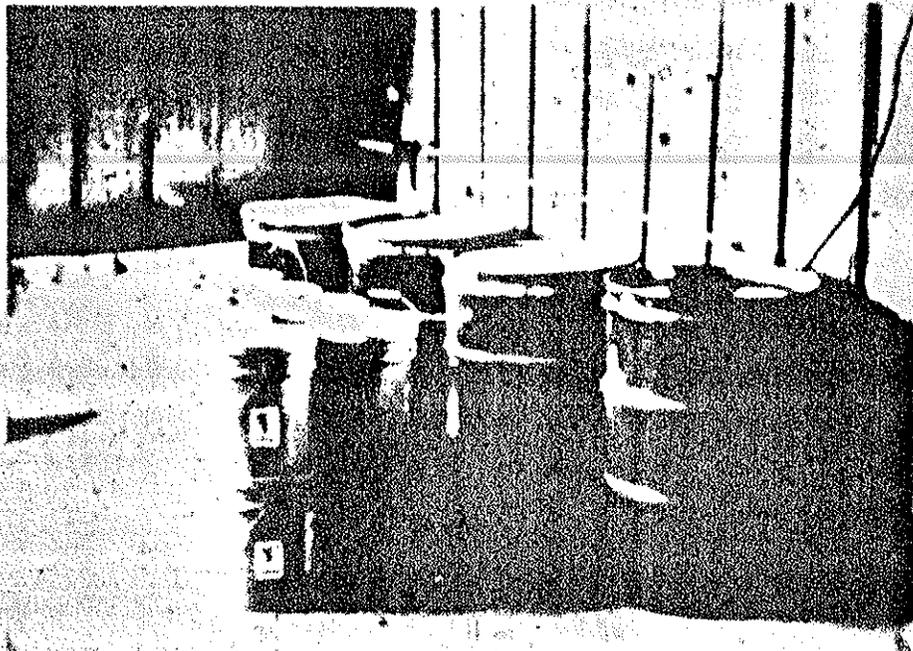
Photo #1 (21)

Storage Area

Note product storage and empty waste drums.
